## ***Merkel & Associates, Inc.***

July 7, 2005  
M&A #01-024-17

### **RE: Qualitative Evaluation of Escondido Creek and an Unnamed Tributary for Sediment Discharge Impacts Associated with Escondido Research and Technology Center**

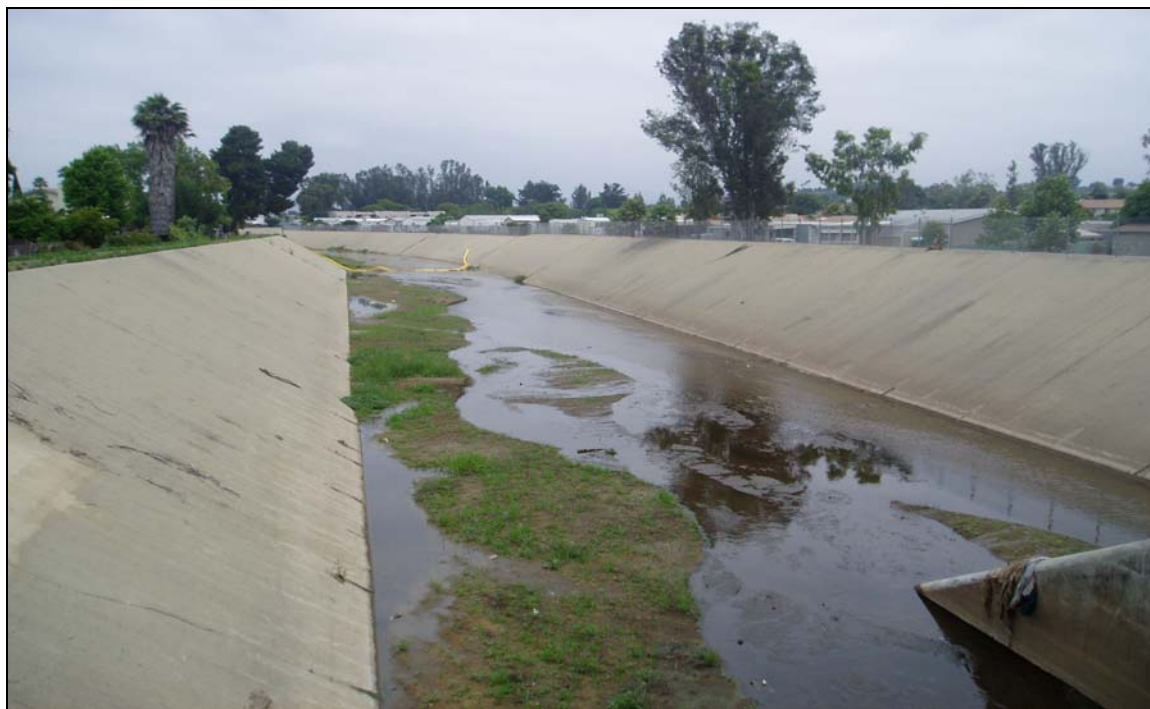
The Harmony Grove Bridge occurs upstream of the ERTC site and thus serves to provide a baseline condition of Escondido Creek. At the Harmony Grove Bridge, Escondido Creek transitions from a channelized drainage to a natural bed. The examination of this area was limited to observation made from the bridge due to the presence of chain-link fences that prevented closer inspections of the creek channel and the sediments present. Observations made included sediment accretion on channel bottom that appeared to contain a mix of clay, silt, and sand, with some organics, with the fine dark sediments being more abundant than sand.

Given the deposition of well graded sediment materials within the concrete channel, it is clear that significant sediment transport from upstream areas occurred during the past rainy season and that substantial deposition occurred during waning flows.

**Photo Point 1.** Channelized portion of Escondido Creek north from the Harmony Grove Drive Bridge (16 June 2005).

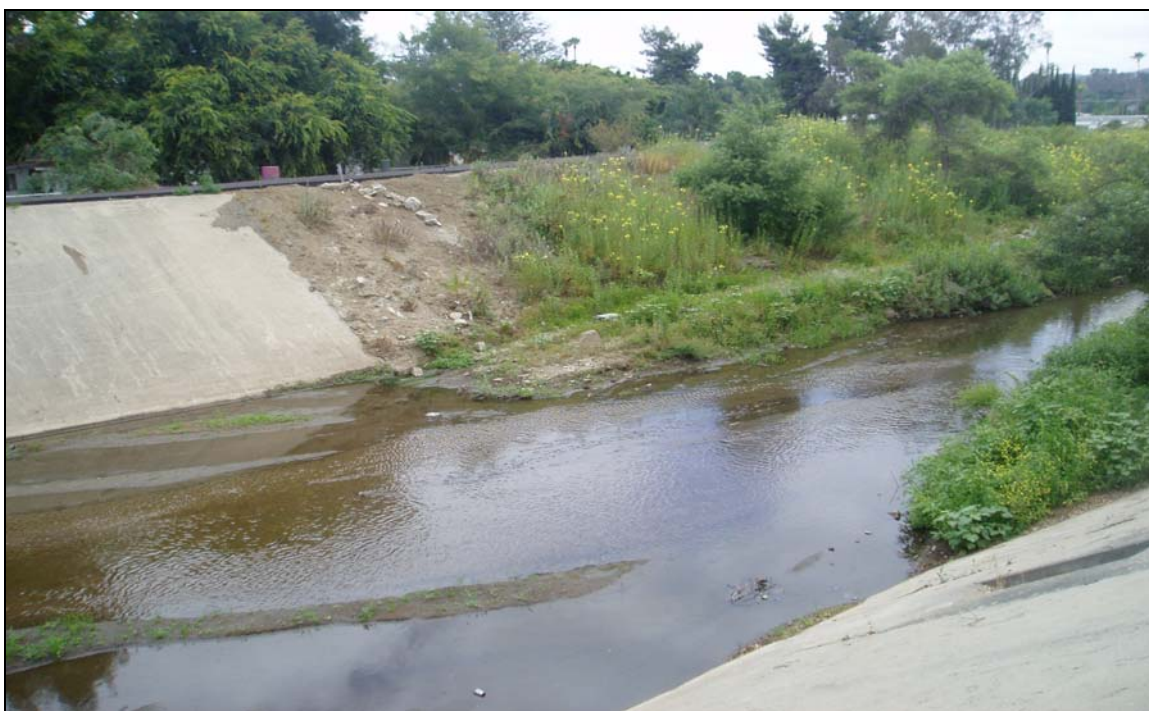
**Photo Point 2.** Escondido Creek south from the Harmony Grove Drive Bridge (16 June 2005).

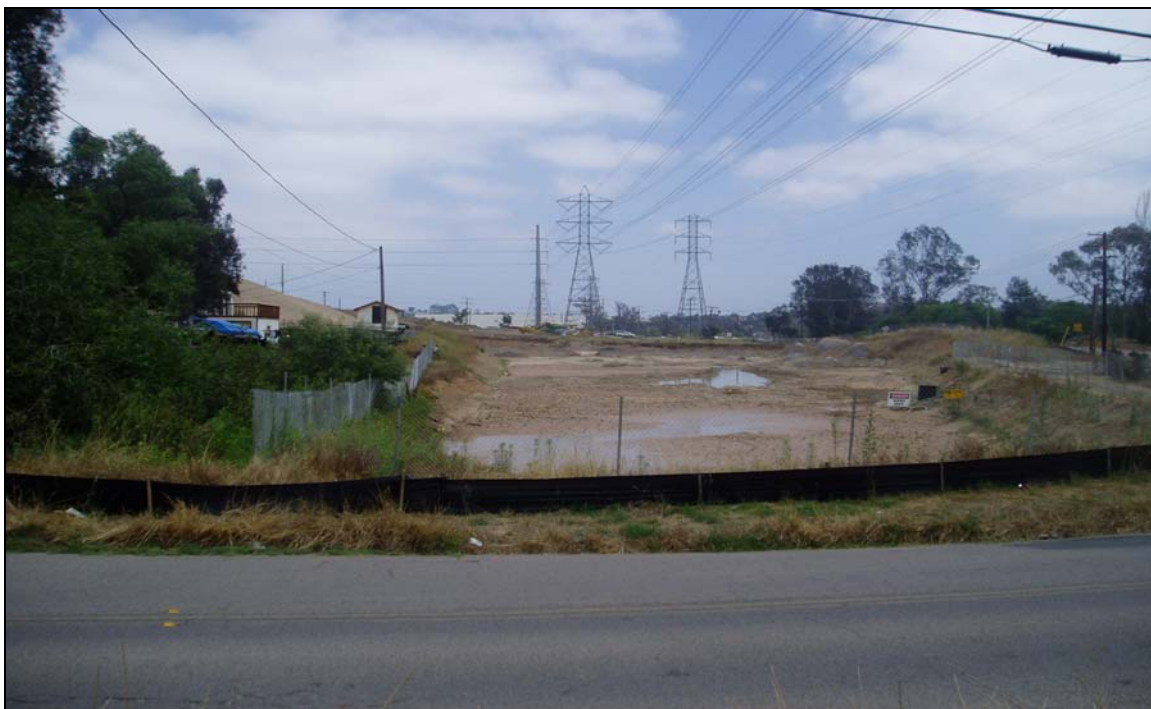
The Kauana Loa sediment catchment basin is located adjacent to the southwest corner of the ERTC project site and north of Kauana Loa Drive. The basin was nearly dry, consequently no discharges were occurring during survey. The majority of the basin substrate was showing the typical cracking pattern as the sediments dried. Very fine silts were observed on the dry plastic liner used to direct basin flows into an off-site culvert located under Kauana Loa Drive.

**Photo Point 3.** Nearly dry sediment catchment basin located in the southwest corner of the ERTC project site (16 June 2005).

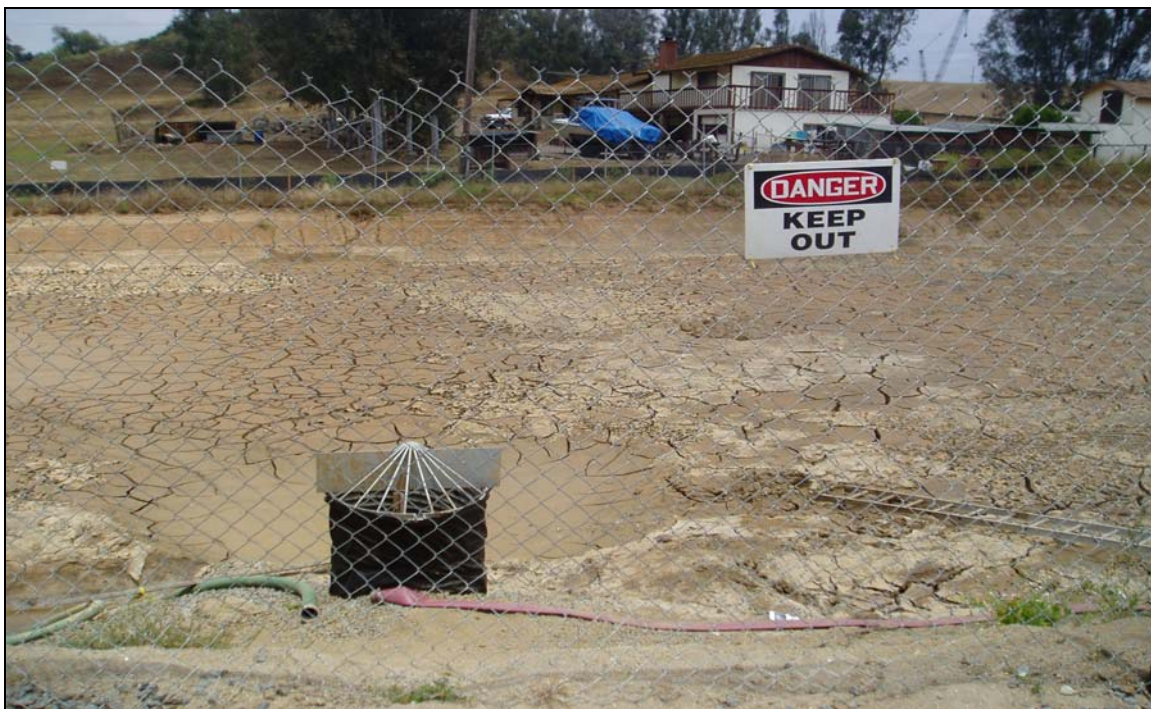
The most important observations from the basin are the presence of fine sediments up to the basin discharge point. This observation suggests that discharges of sediments did occur from this basin to the downstream unnamed tributary. However, the observations also suggest that the discharges to downstream areas were fine fraction sediments rather than sandy sediments. As such, downstream areas of sediment accretion that could be associated with the ERTC project should contain fine sediments rather than sandy sediments. Sandy sediment accretions would likely be derived from other sources.

**Photo Point 4.** Area of the sediment catchment basin including the 36" outflow riser (16 June 2005).

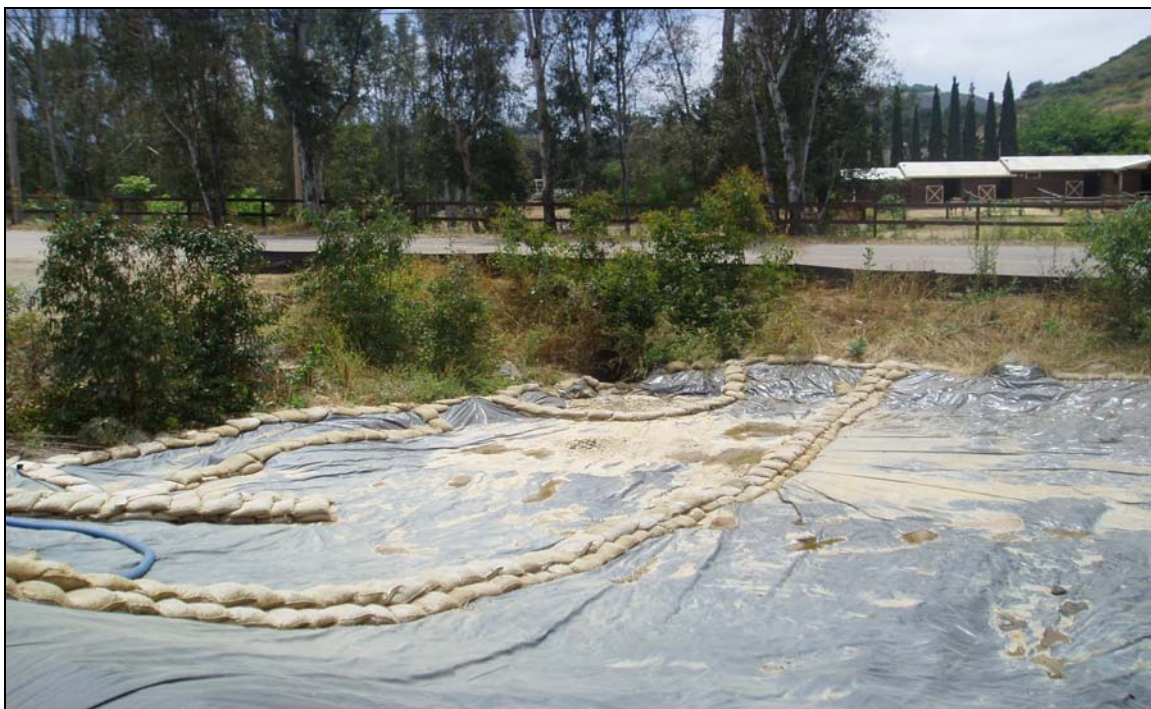
**Photo Point 5.** Plastic lined area that receives the discharge from the sediment containment pond and funnels it to the culvert under Kauana Loa Drive. (16 June 2005).

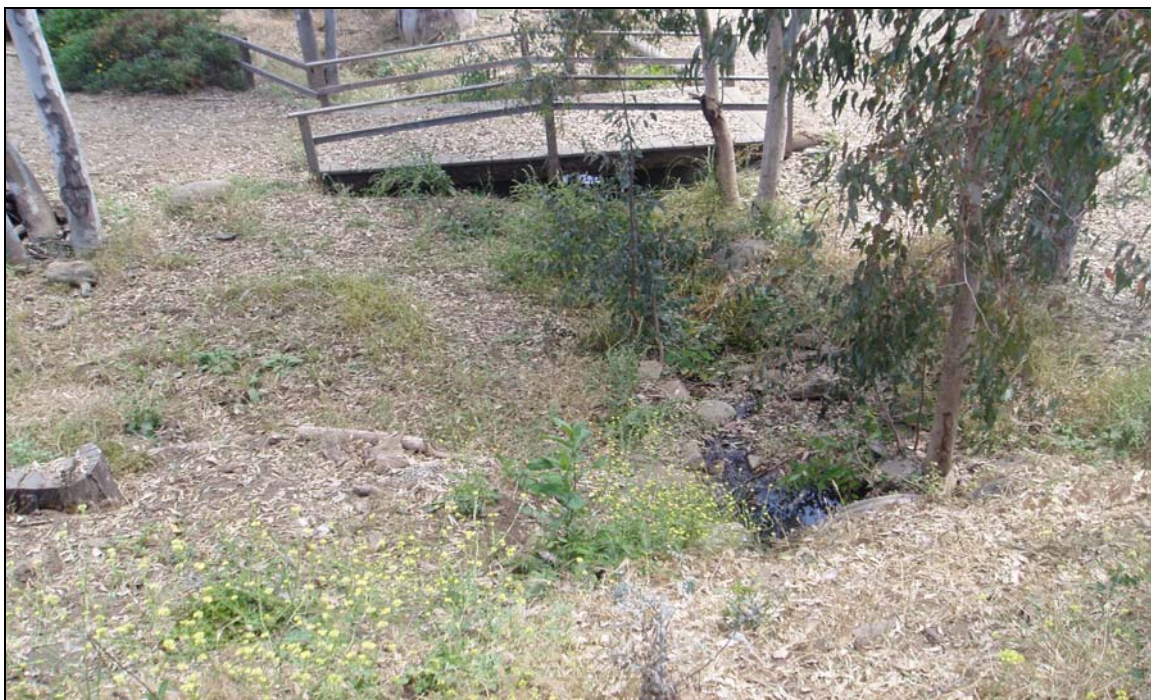
This highly seasonal south flowing drainage collects and carries storm water from upland areas directly into Escondido Creek. The drainage reach begins immediately south of Kauana Loa Drive (Photos 6-7) and continues to below Harmony Grove Road on into Escondido Creek (Photos 8-17). Below the discharge point of the Kauana Loa Drive culvert, no fine sediment was observed in the drainage channel. Within the reach from Harmony Grove Road south to the confluence of the Escondido Creek the substrate of the tributary channel largely consisted of older firmly-cemented clay deposits that are resistant to erosion and which prevent this channel from becoming deeply incised. The channel bed consists of a series of mini scour pits where high velocity flows have cut through the clay layers.

**Photo Point 6.** Portion of the unnamed tributary of Escondido Creek and culvert south of Kauana Loa Drive (16 June 2005).
